INJECTOR ENCODING

GB Remanufacturing, Inc.

TB-0116-E

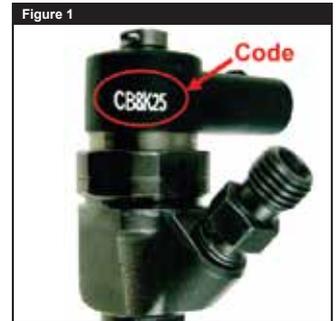
The GB 717-502 injector used on the 2004-2006 Sprinter Van is marked with a six digit alphanumeric code that must be entered into the ECM using a scan tool. The encoding refers to the injectors flow and operating characteristics and is unique to each injector. The ECM uses this code to adjust baseline fuel delivery for each injector and cylinder. It is mandatory to enter the injector's code to achieve proper engine performance. When a GB 717-502 injector is installed, the original code located at the top of the injector stator is no longer used. This is replaced with a new code on the side of the stator, such as "CB8K25" (**SEE FIGURE 1**)

1. Turn ignition switch ON.
2. Using a DRB III® select ENGINE then MISCELLANEOUS.
3. Select LEARN INJECTORS.
4. Using the up and down arrows, scroll to the appropriate injector.
5. Using the right and left arrows, set the injector to proper code.
6. Once injectors are coded, cycle ignition to complete.

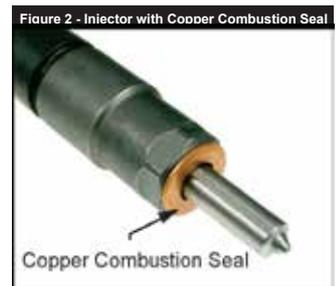
COPPER GASKET (FIGURE 2)

When replacing the injector the copper combustion seal must be replaced and is included with GB's remanufactured injector. In most cases the copper combustion seal will remain on the old injector when removed. Verify the copper seal is present on the injector being replaced, if it is not, inspect the injector bore for the seal and remove as necessary. Inspect the injector bore for damage, contamination and or corrosion. Correct any defects with the injector bore prior to installing the new injector.

NOTICE: Failure to replace the copper seal and properly torque the injector will result in injector failure and may cause severe engine damage. Failure as a result of these conditions is NOT covered by GB's limited warranty.
